2 Year Follow-up on Full Thickness, non-retracted Rotator Cuff Tear Treated with Stem Cells

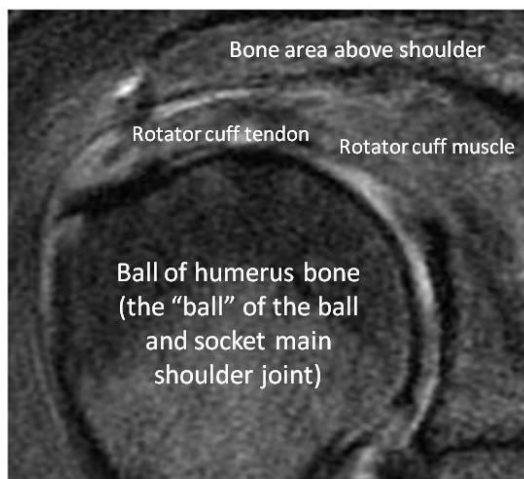
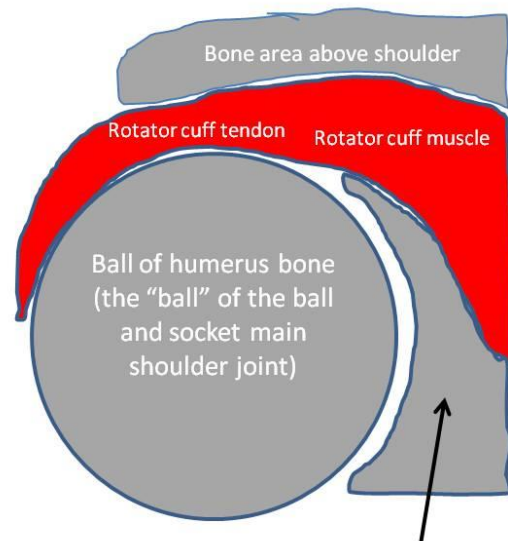
2.04.2008 COR MRI

COR MRI. ET=7, TR=2350, TE=62.2

Acetabulum or shoulder joint socket

The image above is this patient's pre-injection coronal MRI. A coronal MRI slice is one that lets you look from the front or the back. Here you can see the MRI on the left and the diagram of the MRI to the right. The rotator cuff tendon is the area of interest. The rotator cuff like any muscle has two parts, the muscle belly and the part that attaches the muscle to the bone, the muscle tendon. Rotator cuff tears commonly occur at the muscle tendon area. In addition, MRI images

come in many different flavors, some show water as bright or a lighter color, which is what's being shown here in these PDFS sequences. So on this image, a darker appearing tendon is good, one with light spots in it is bad. A normal rotator cuff tendon in this type of MRI sequence would be a uniform darker color or black (depending on age).

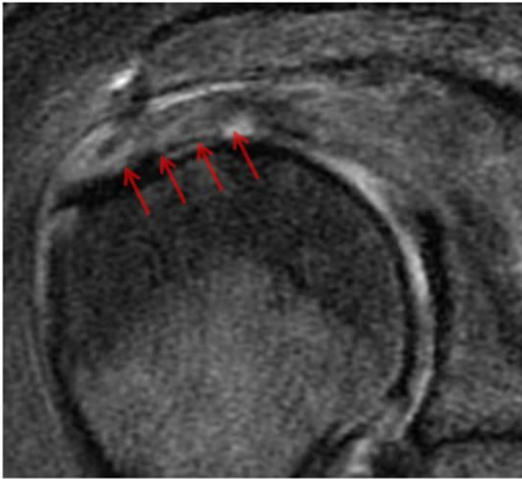
2.04.2008 COR MRI

COR MRI. ET=7, TR=2350, TE=62.2

Now for the patient MRI's. Above on the left is an MRI taken 2 months before her stem cell injection in April 2008, the image on the right is her 2 year follow-up MRI. The left MRI shows the rotator cuff tendon (red arrows) which is bright in color and mottled in appearance. This means that it's a full thickness rotator cuff tendon tear with severe degeneration (she's 78 years old at the time of this picture). To the right is her two year follow-up MRI showing a darker appearing rotator cuff tendon (yellow arrows) without any light color that goes all the way through the tendon (she's 80 years old in this picture). Clearly an improvement that's still holding and demonstrated not only by her reports of no pain and full function, but also objective MRI imaging two years later.

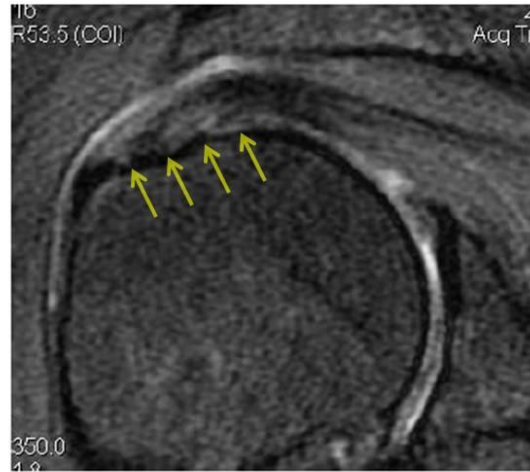
6.24.2010 COR MRI

COR MRI. ET=7, TR=2350, TE= 62
